## FLOOR

### Improvement of misplaced holes/cutouts

Nr.  
B12-110

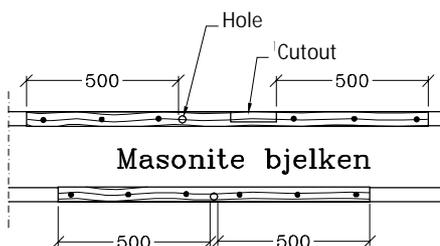
No holes or cutouts are allowed in the flanges.

Flanges with holes or cutouts must be reinforced with wood (without defects) on both sides of the flange, lengths are show in the figure to the left. The wood must have a minimum dimension of 38x48 mm for H-quality beams and 48x48 mm from HI-quality. Knot sizes under 7 mm is allowed. The wood must be glued with construction glue (Polyurethane or epoxy based) and fastened with screws 15-20 mm into the flange. Screws must be placed according to the figure to the left. Nails must not be used.
